RE: Greenwood Park – Mary Miss Double Site

Greenwood Park Inspection Report

Date of Inspection 5/24/2024 at 10:00 AM

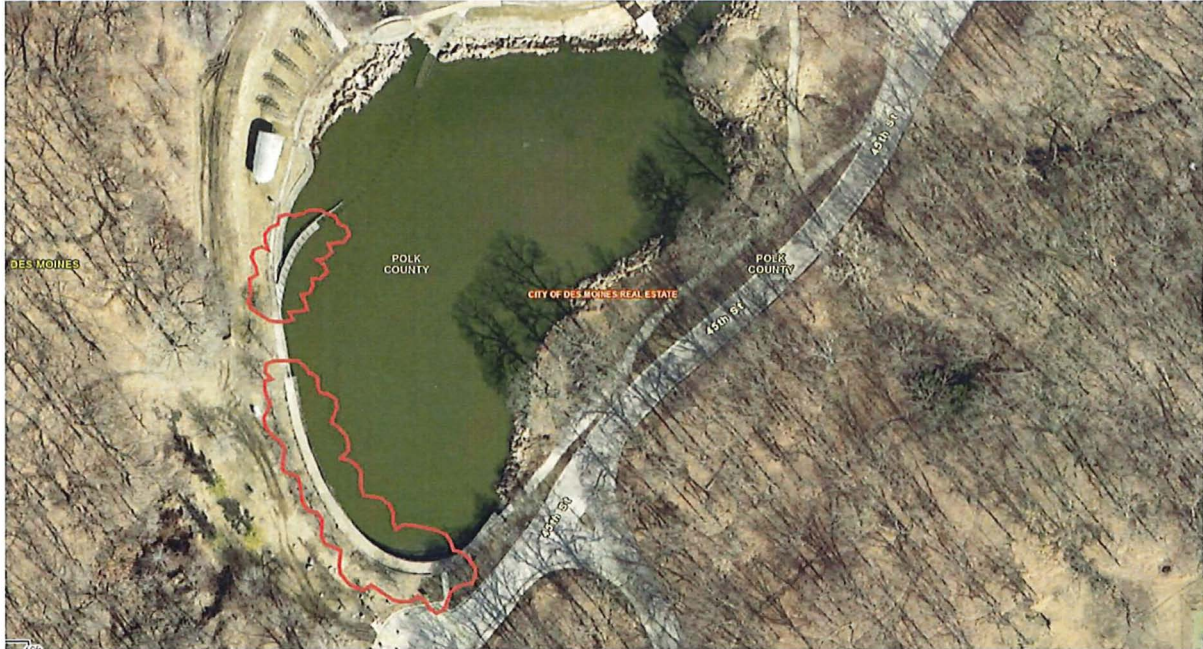
1. General dilapidation
 - a. The boardwalk construction consists of pressure treated preservative lumber walkway and railings constructed over a steel and concrete framing system.

- b. The wood structure is failing due to decay and deterioration and can no longer support its intended design capacity
 - c. Areas of the guardrails and boardwalk are missing spindles and floor boards due the deterioration of the wood components

2. Severe wood decay
 - a. The pressure treated preservative lumber on the boardwalk surface and the railing are suffering from severe wood decay.
 - b. The wood beams spanning the boardwalk are saturated with moisture from decay and can no longer support the required design loads for a boardwalk.

- c. The decay is also affecting the strength of the wood railing system. The decay is so severe that wood can no longer receive screw fasteners to maintain the required structural loading of 50 lbs/foot required in the International Building Code.

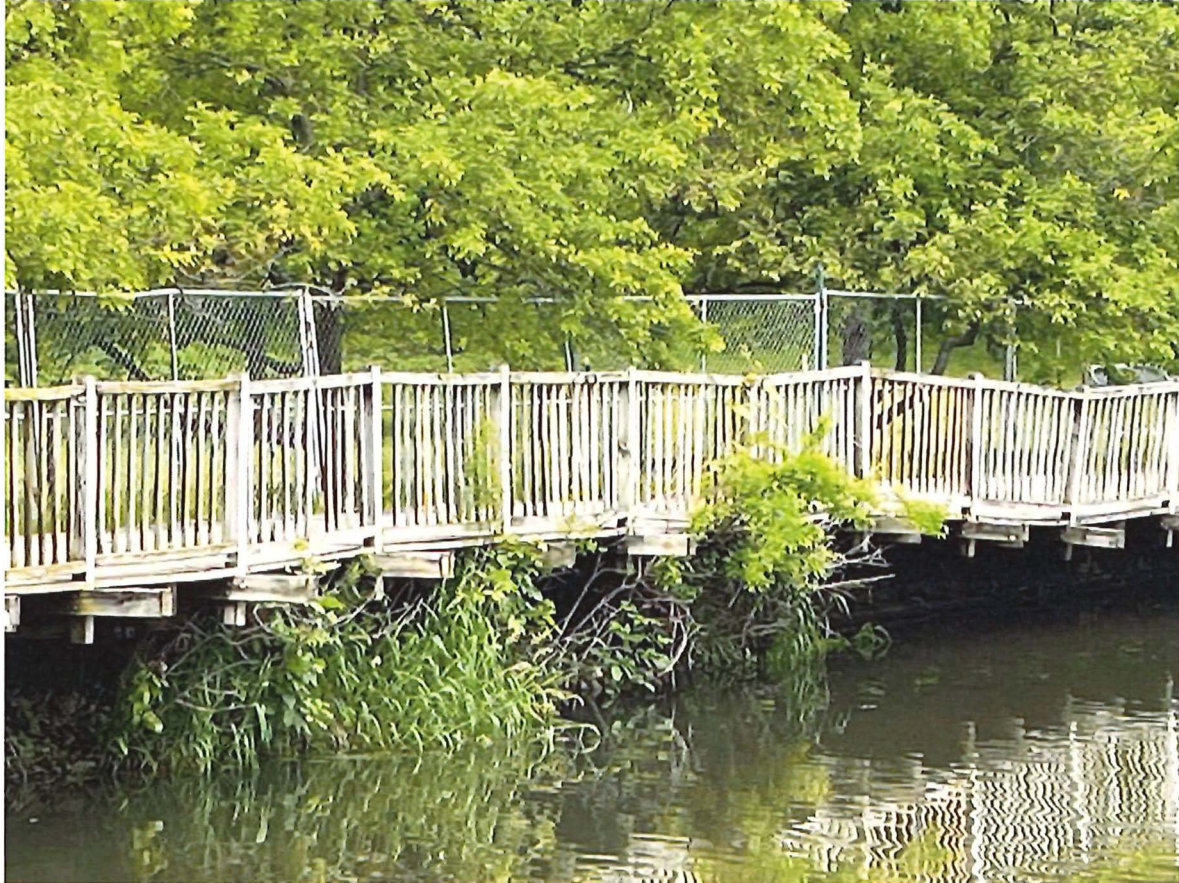
3. Structural instability

- a. Due to the severe wood decay the boardwalk floor framing is missing boards and the wood framing system that holding up the boardwalk has lost its design strength and appears to not be able to handle the weight of people walking on top of it.
- b. The wood decay has also caused obvious signs of heaving and buckling in the framing system making the system structurally unstable.

Per Chapter 26-101 & 26-157 of City Code of Ordinances, the building official can deem a structure unsafe due to dilapidation, decay and/ or structural instability. The boardwalk at Greenwood Park meets all of these criteria and is unsafe to be used. The south portion of the boardwalk is fenced off from public use. This mitigation strategy is keeping the structure from being used by the public. If the structure is wished to be used again, the structure will need to be replaced or repaired by removing all of the decaying wood structure and railing.
